TRIAL USING VEGWARE FOOD WASTE AND PACKAGING TO TRACK  
BIODEGRADATION THROUGHOUT THE COMPOSTING PROCESS

Purpose of trial:

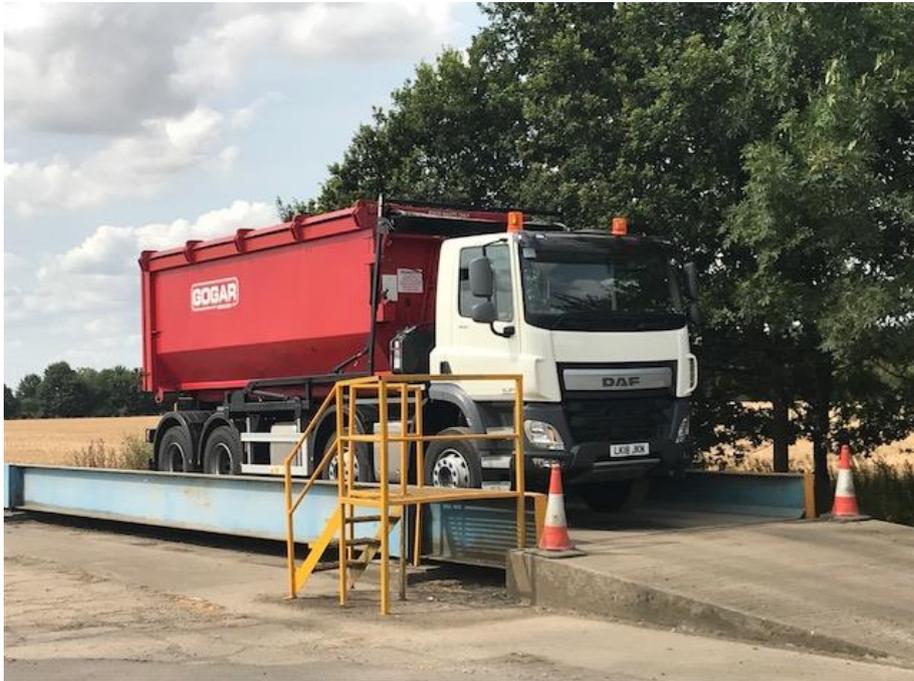
Image 1

Delivery on weighbridge:

The 1.36 tonnes of material was weighed on arrival, then tipped within the reception hall of the composting facility and mixed with 11 tonnes of comingled garden and food waste which is the normal material composted on this site. The aim was to have a mix ratio of 10% food and packaging waste mix.

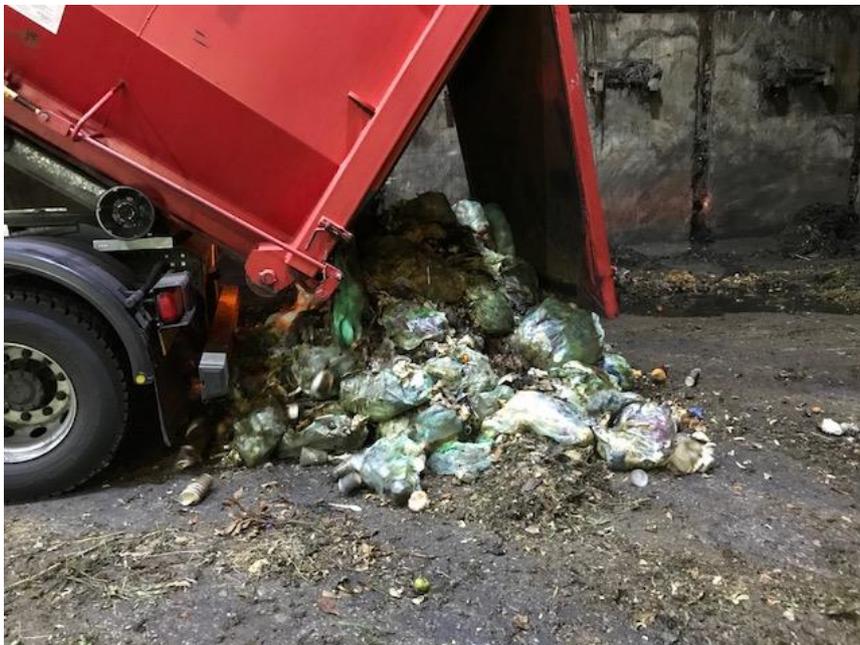
Image 2

Tipping material in the reception hall:

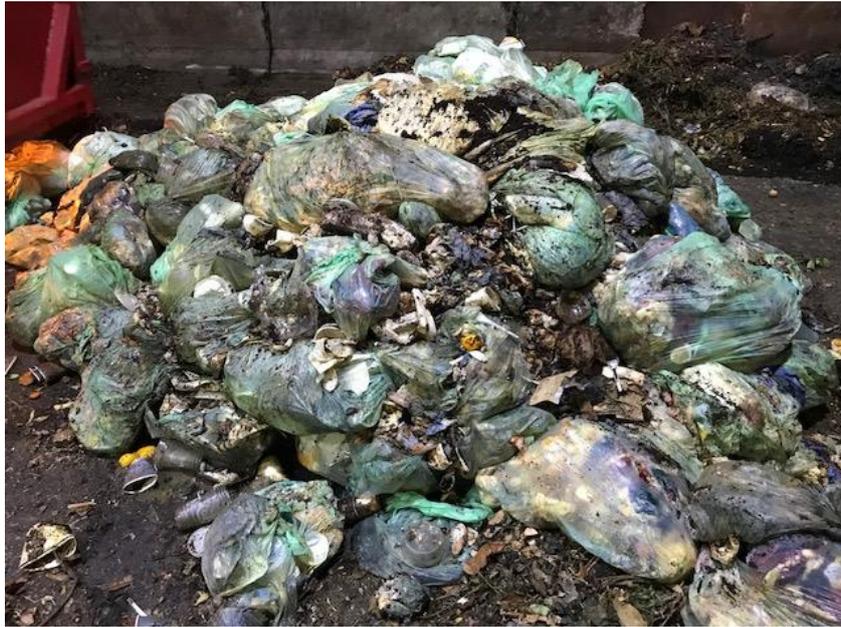
Image 3

Food waste and packaging including compostable bags tipped in reception hall:

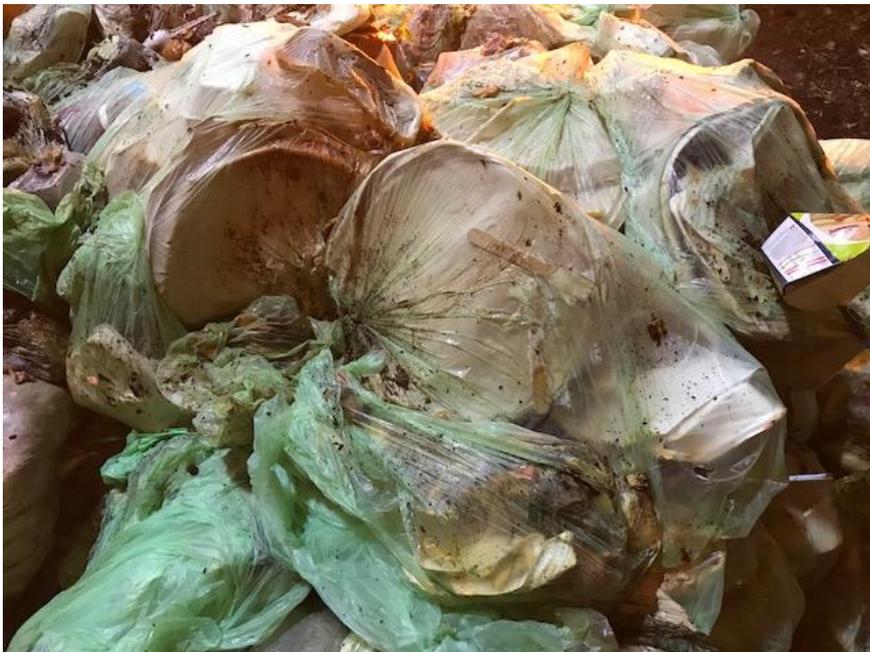
Image 4

Close up of Vegware compostable plates and bags:

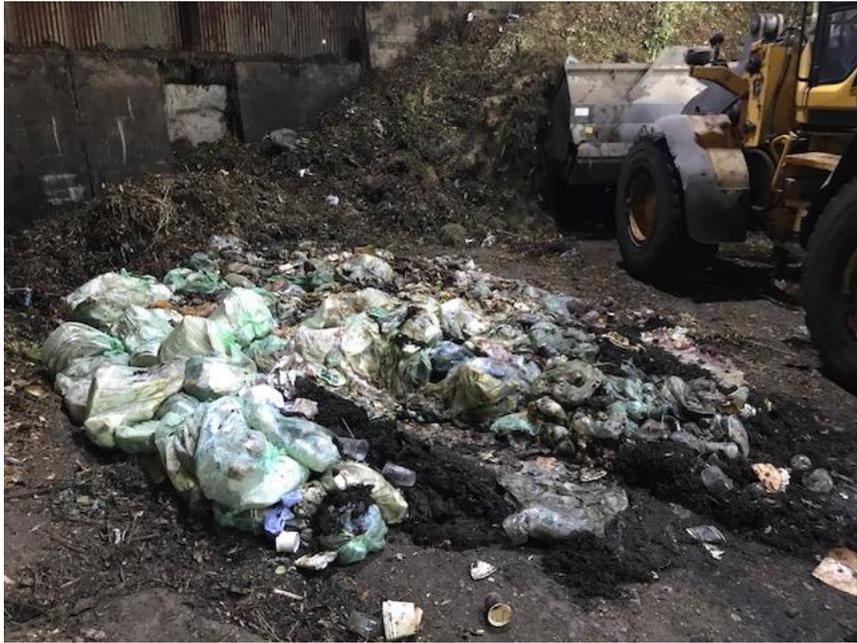
Image 5

Material spread on reception-hall floor prior to blending with garden and food waste:

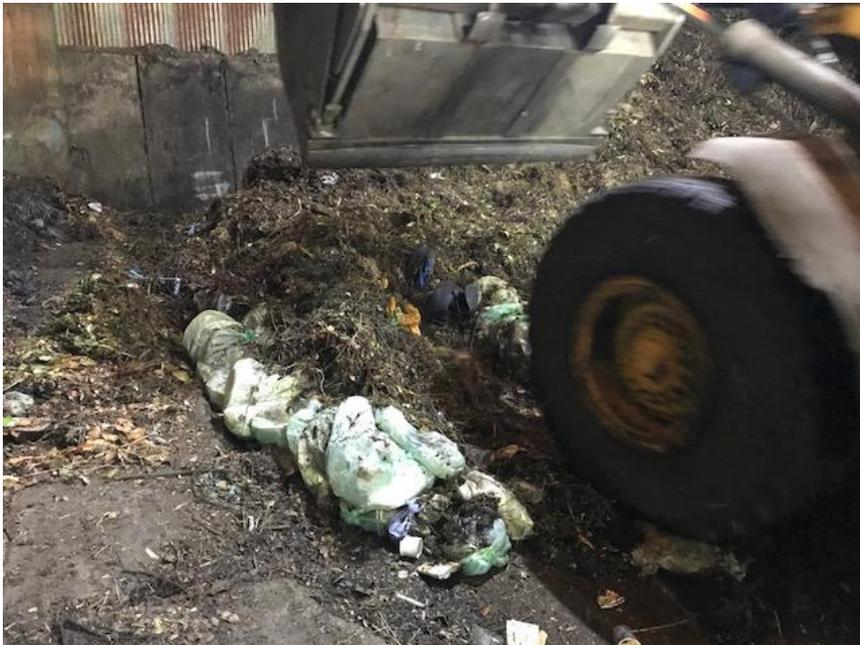
Image 6

Blending comingled garden and food waste with packaging:

The two fractions were mixed initially using a loading shovel and then this material was placed into a Willibald high speed shredder. The gate on this machine was reduced in order that the shred size on the compostable cutlery and plates was optimal. A squeeze test (a recognised means of determining the percentage moisture of compost) was carried out on the blended material and it was decided that at approximately 60% moisture, this was adequate to compost effectively.

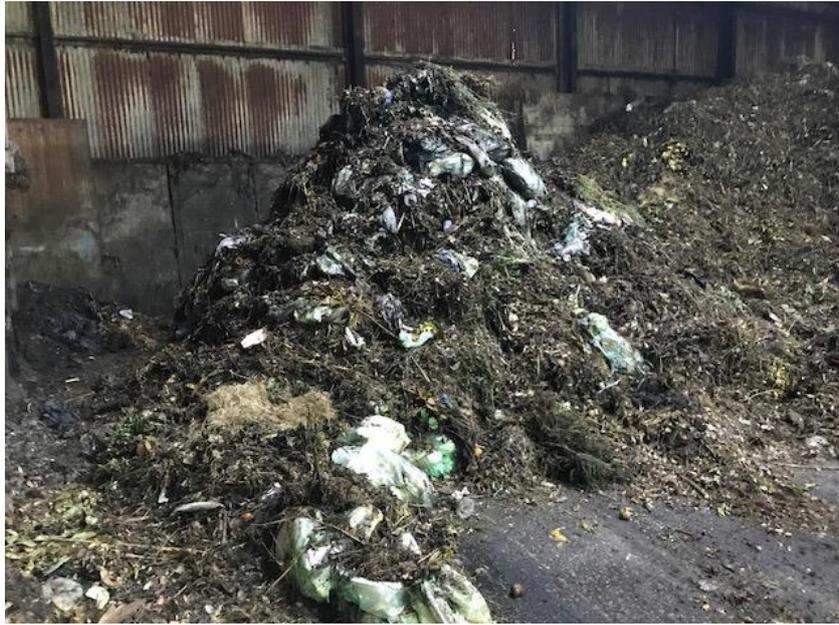
Image 7

Blended material prior to shredding:

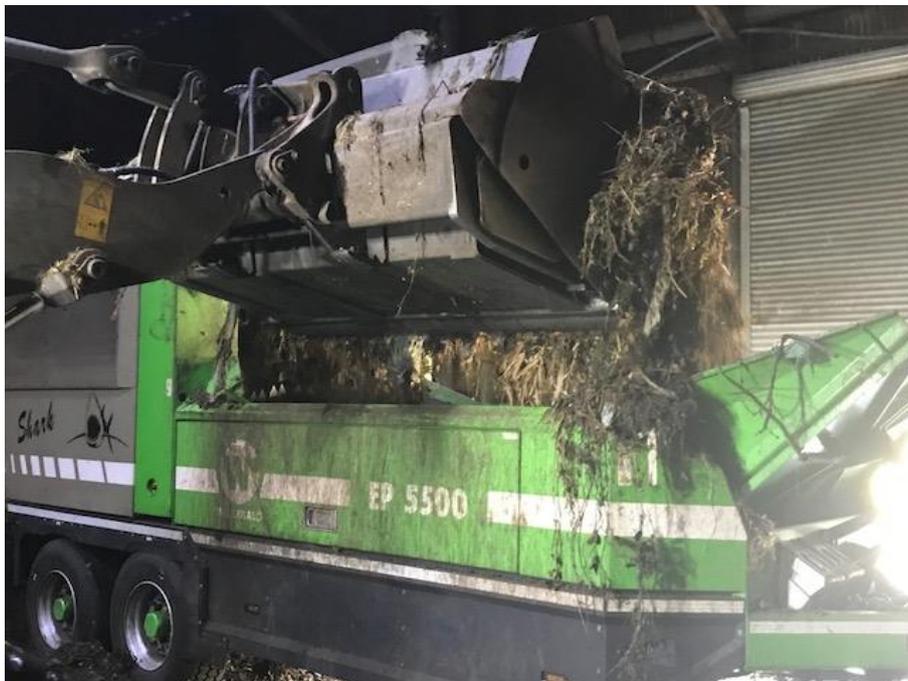
Image 8

Willibald high-speed shredder loading with blended materials.

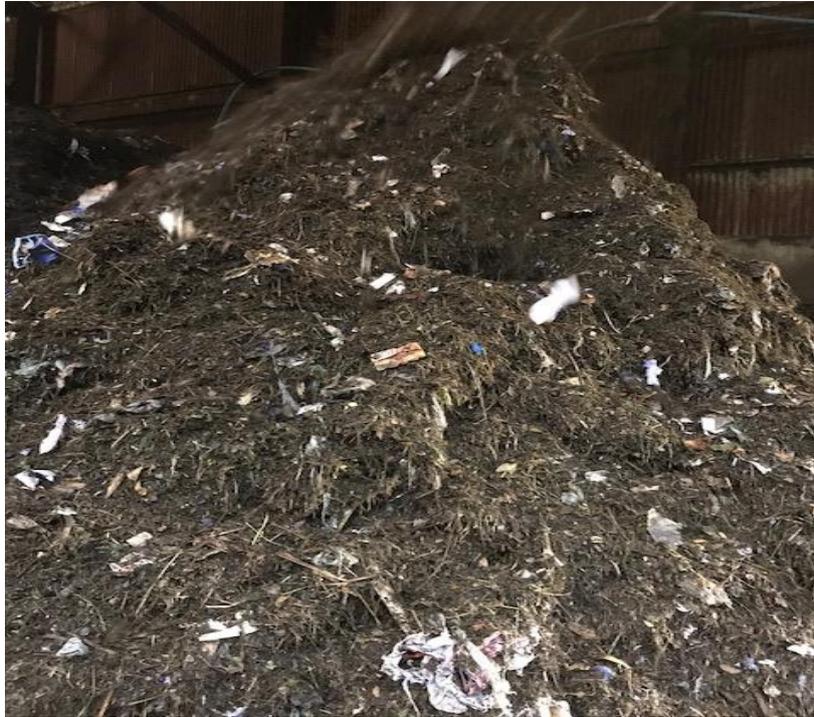
Image 9

Shredded blended material prior to tunnel filling:

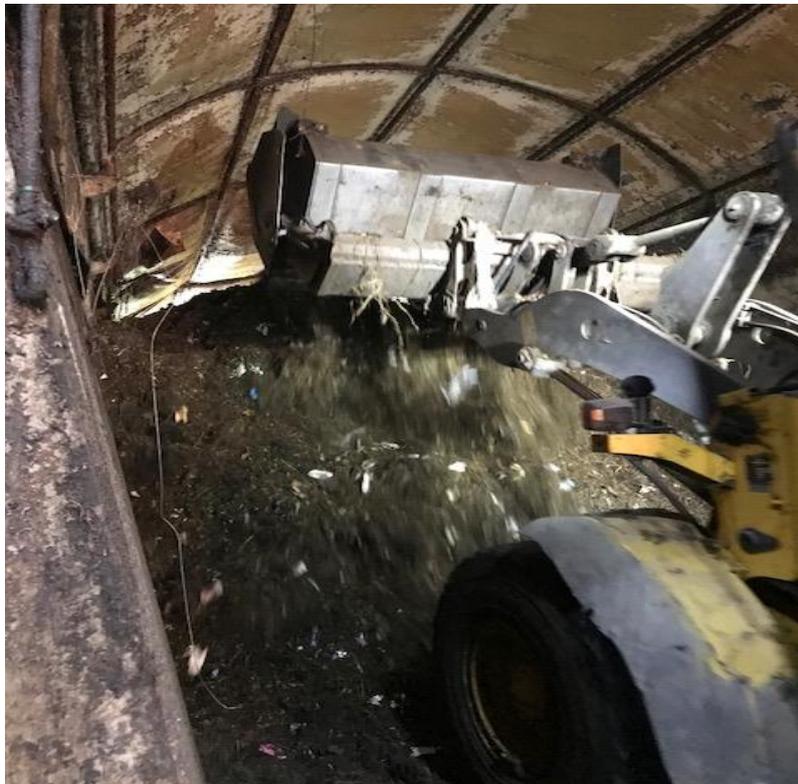
Image 10

Tunnel filling using a loading shovel:

The shredded material was then filled using a loading shovel into a 400 tonne capacity composting tunnels to undergo its sanitisation step of the composting process. This site composts to the EU standard of 70 degrees C for one hour (minimum) at 12 mm particle size.

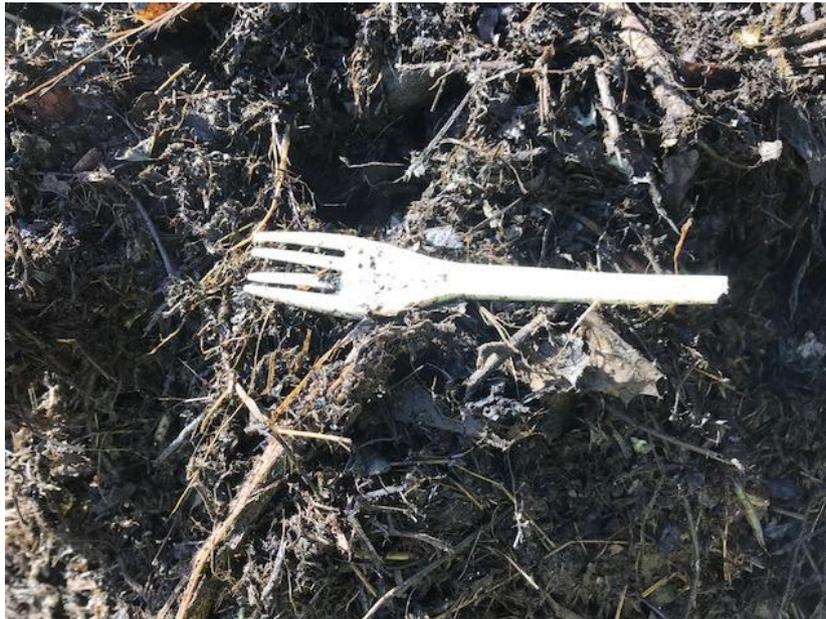
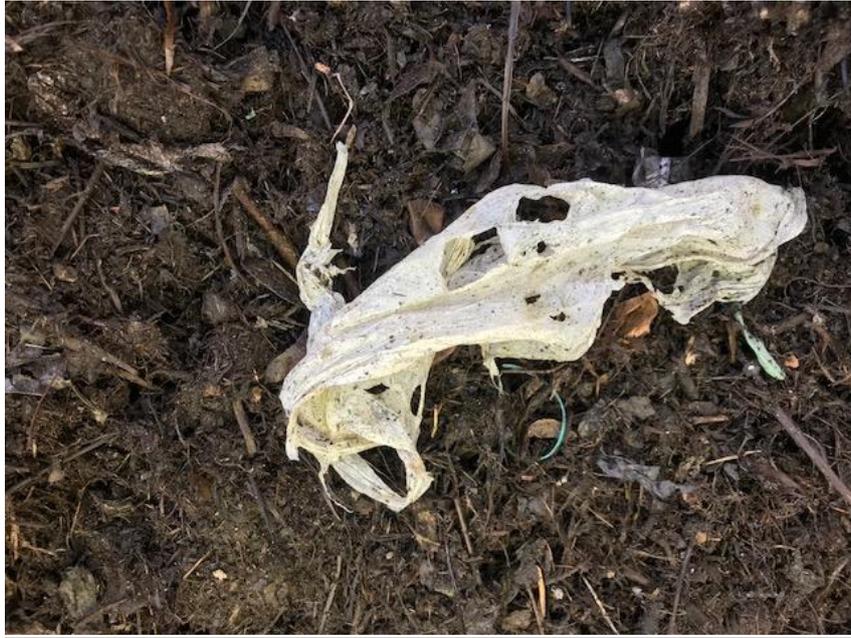
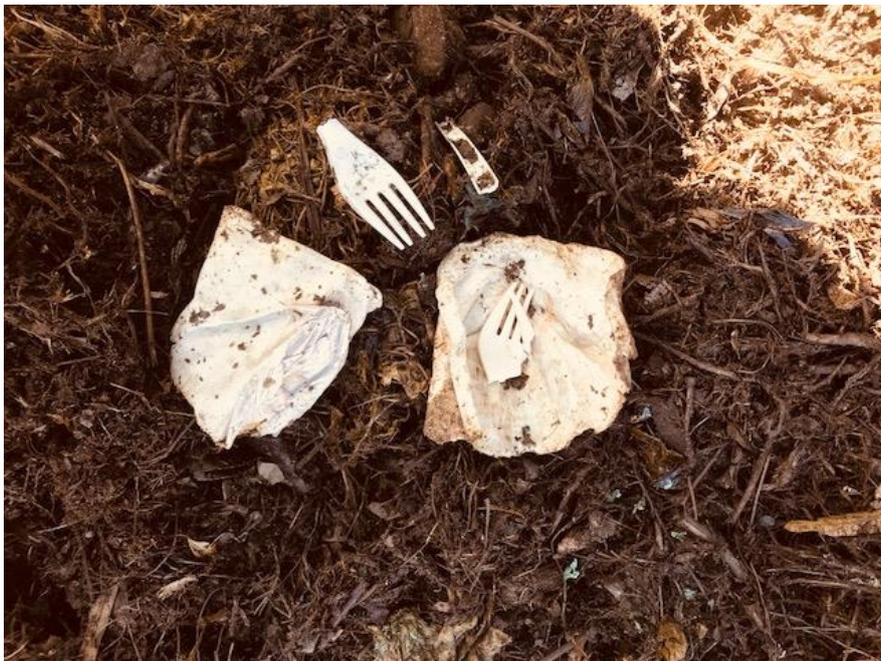
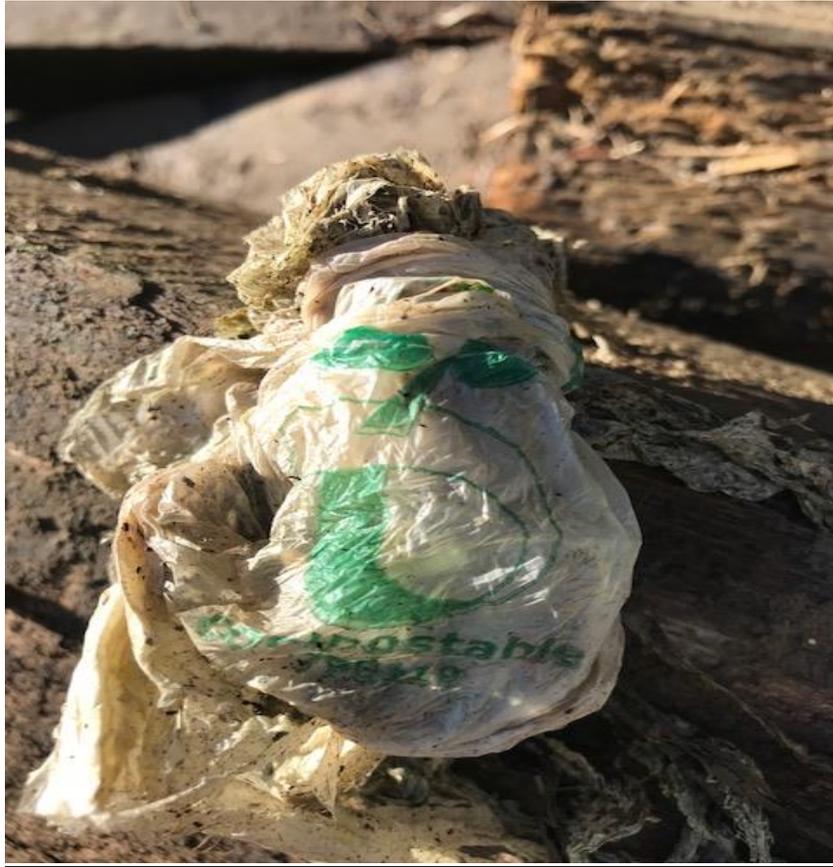
Images of Vegware packaging after 22 days in the composting tunnel.(images11-14)

- The paper plates and cups showed significant disintegration and were quite difficult to find.
- The Vegware bags used to hold the compostable cutlery, plates and cups had all but disintegrated other than the knots which were obviously thicker than the normal bag thickness.
- The cutlery however was still clearly discernible but was distorted as a result of the heat from the composting process.

The pictures below show the materials on exiting the tunnel after 22 days in the tunnel. The temperatures within the tunnel are monitored 24/7 and managed through an integrated control system that controls air volumes and input of ambient air.

Blending with co-mingled food and green waste		18 <sup>th</sup> July 2018	
Shredding of blended material		18 <sup>th</sup> July 2018	
Filled into ABP approved IVC		18 <sup>th</sup> July 2018	
Temperature monitoring commenced		18 <sup>th</sup> July 2018	Temperature maintained at between 71.3(minimum) and 75.9 (maximum) over the duration.
Tunnel emptied	22	9 <sup>th</sup> August	Inspected for compostable cutlery and packaging (see photos) 22 days in tunnel.
Transported to Lackford (Permitted OAW composting site)		9 <sup>th</sup> August	Loaded into walking floor trailer and transported by road to alternative site for maturation.
Compost placed into windrows		9 <sup>th</sup> August	3.5 m high by 3m wide windrows
Turned	36	23 <sup>rd</sup> August	Turned once prior to screening
Screened	49	5 <sup>th</sup> September	Screened to 10 mm for use in agriculture (see picture # 14)
Despatched	62	18 <sup>th</sup> September	To local farm for spreading on stubbles

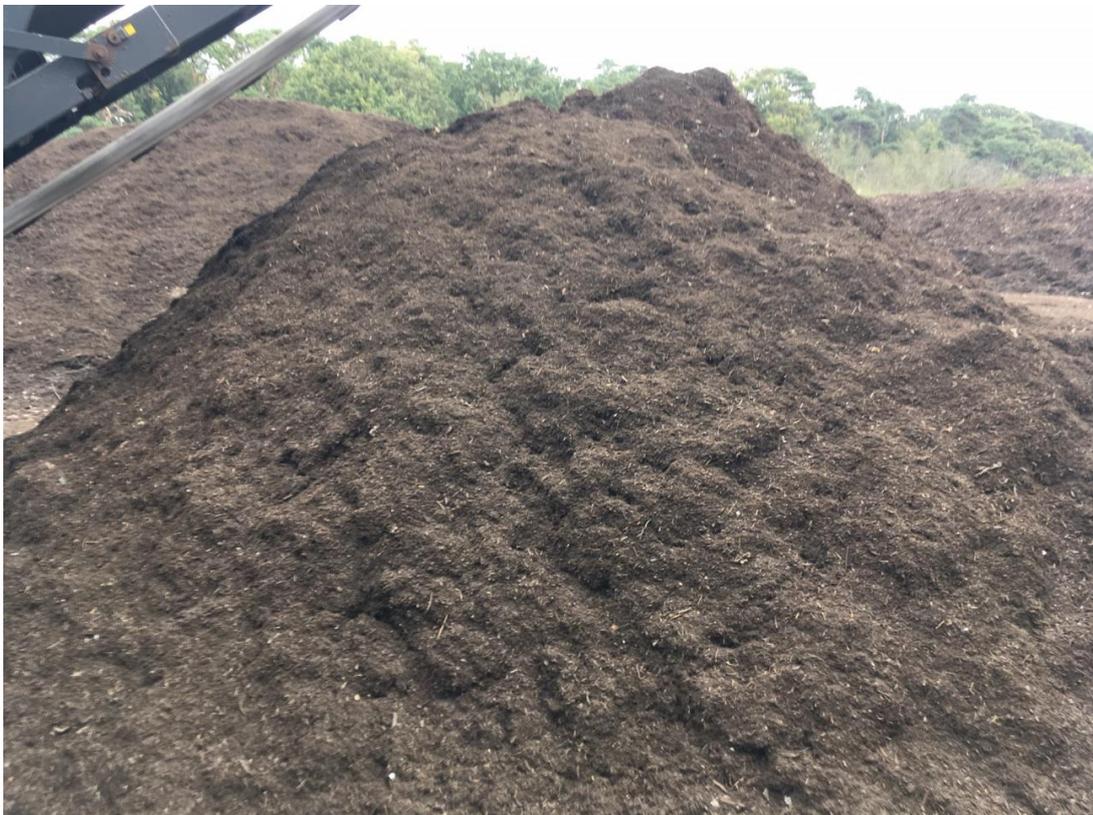
Image 15

10mm screened compost on day 49
